THE SECRETARY
OF THE INTERIOR'S
STANDARDS FOR
THE TREATMENT
OF HISTORIC
PROPERTIES

GUIDELINES FOR PRESERVING, REHABILITATING, RESTORING & RECONSTRUCTING HISTORIC BUILDINGS

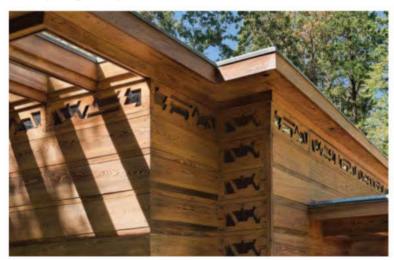
Many historic buildings have wood structural systems and features, such as stairs or columns. The majority of both practical and decorative features, particularly on the interior, are made of wood, such as flooring and paneling.

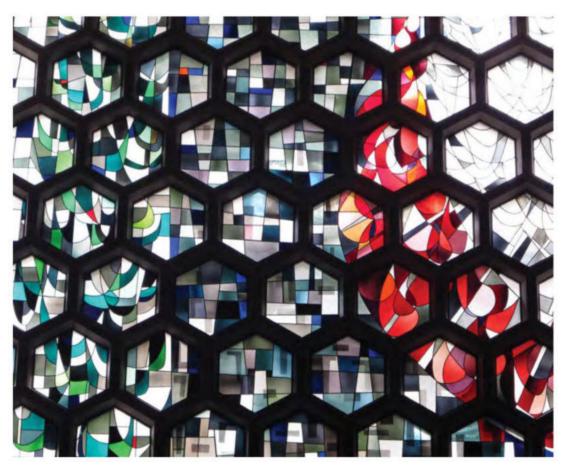
century, architects began using glass curtain walls in Art Modernestyle architecture and, most notably, the International Style. *Tempered glass* is a hardened or toughened glass which began to be used in building construction around 1940. By the middle of the 20th century, glass as a cladding system became synonymous with curtain wall systems.

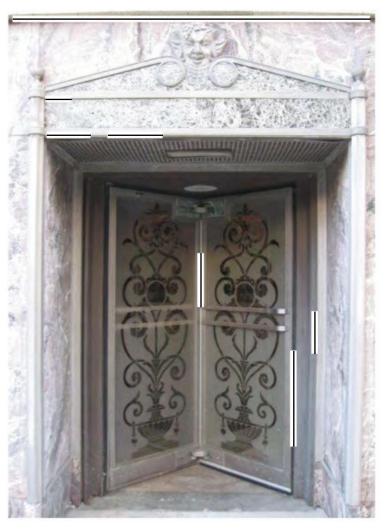
ally, entrances and porches were integral components of a historic building's design; for example, porches on Greek Revival houses, with pediments and Doric or Ionic columns, echoed the architectural elements and features of the building itself. Center, single-bay porches or arcaded porches are evident in Italianate-style buildings of the 1860s. Doors of Renaissance Revival-style buildings frequently featured entablatures or pediments. Porches characterized by latheturned porch posts, railings, and balusters were especially prominent and decorative features of Eastlake, Queen Anne, and Stick-style houses. Deep porches on bungalows and Craftsman-style houses of the early 20th century feature tapered posts, exposed posts and beams, rafter tails, and low-pitched roofs with wide overhangs.

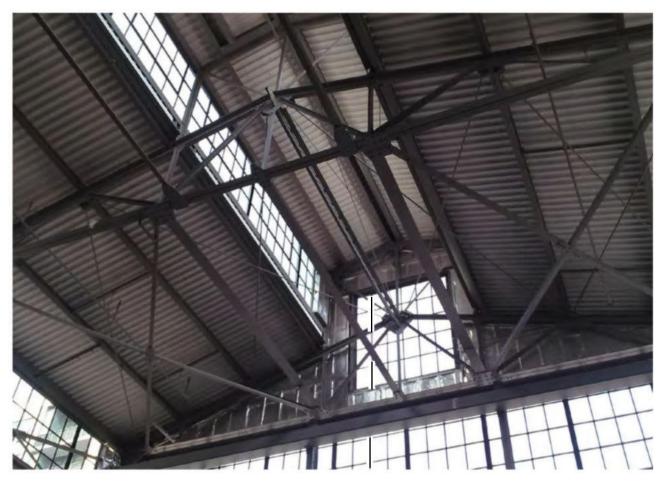
beams, vigas, and outriggers, or masonry foundation walls), they are likely to be important in defining the building's overall historic character. A concealed structural system, although not character defining, may still be significant as an example of historic building technology.

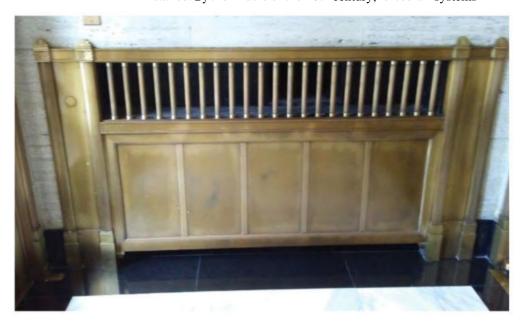
provided both heat and cooling in many buildings. In the late 20th century, as HVAC systems increased in efficiency, they decreased in size, with smaller components, such as split ductless systems with wall-mounted air handlers, cassette ceiling-mounted diffusers, or high-velocity mini duct systems. These systems can be especially useful for retrofitting historic buildings because they are small and unobtrusive. Heat pumps, another late-20th century invention, can help to supplement existing HVAC systems.

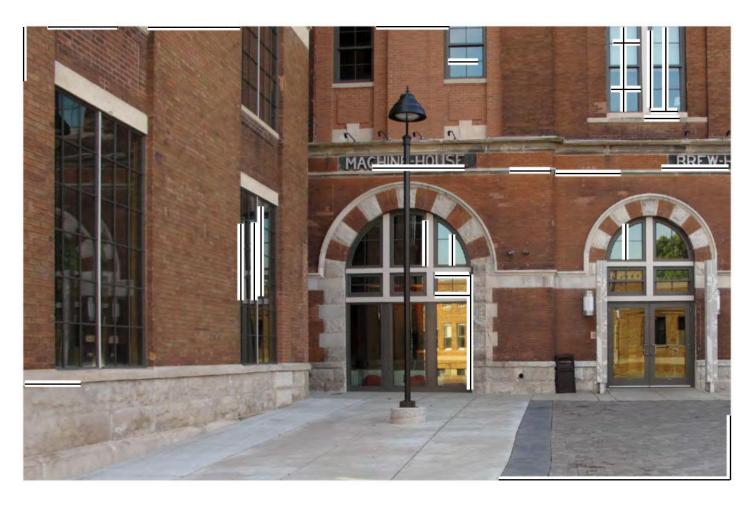
It is often necessary to make modifications to a historic building to make it compliant with accessibility code requirements. Federal rules, regulations, and standards provide guidance on how to make historic buildings accessible. Work must be carefully planned and undertaken in a manner that results in minimal or no loss of historic exterior and interior character-defining spaces, features, or finishes. The goal should be to provide the highest level of access with the least impact to the historic building.

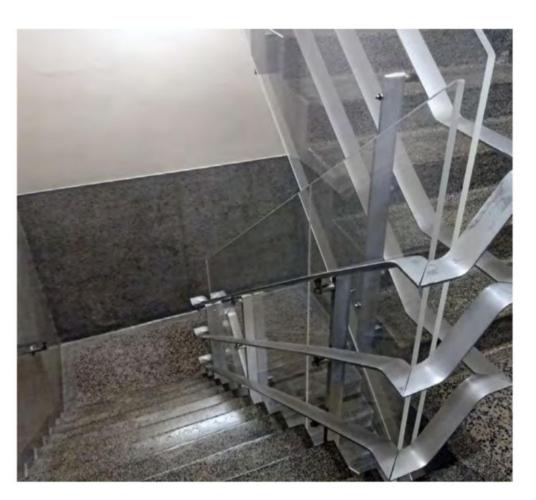
Resilience to Natural Hazards

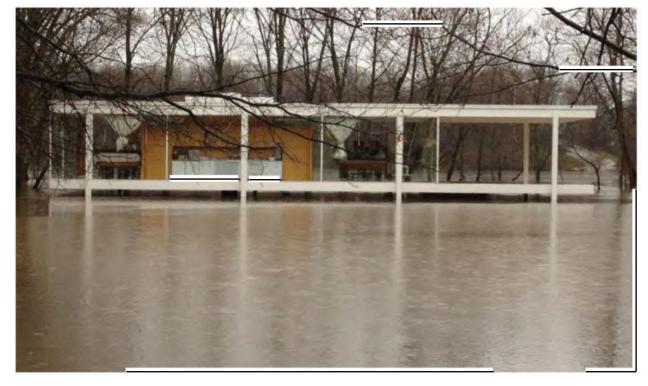
should be taken into consideration when planning preventive treatments. The goal should always be to minimize the impacts to the building's historic character to the great¬ est extent possible in adapting the building to be more resilient.

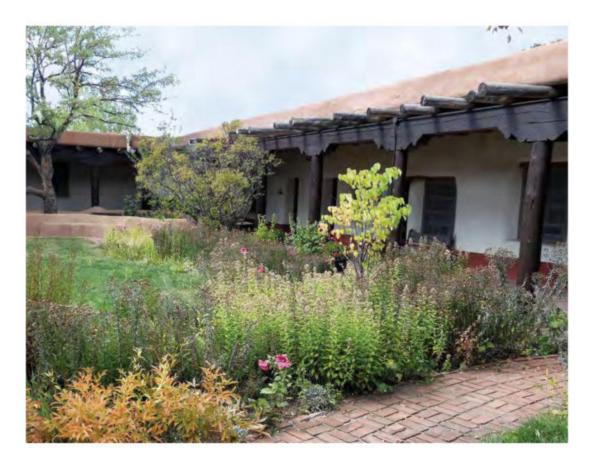
Standards for Preservation

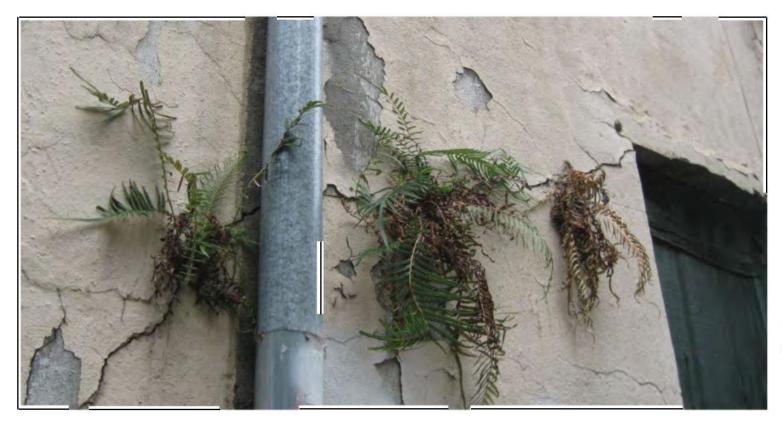
[3] Not Recommended: Cracks in the stucco have not been repaired, thereby allowing ferns to grow in the moist substrate which will cause further damage to the masonry.

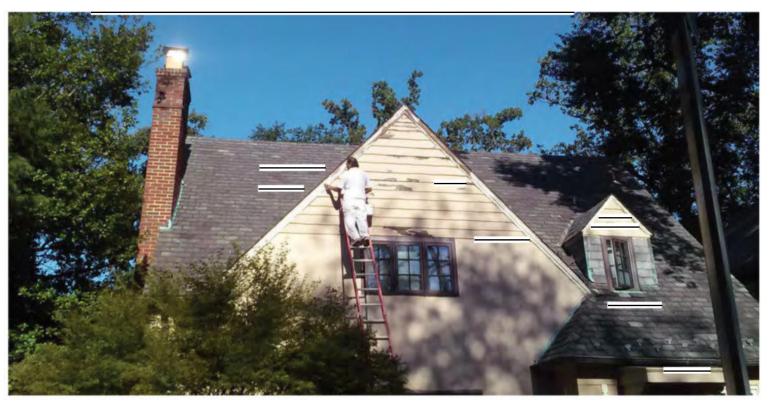
[4] Hand scraping to remove peeling paint from wood siding in preparation for repainting is an important part of regularly-scheduled maintenance.

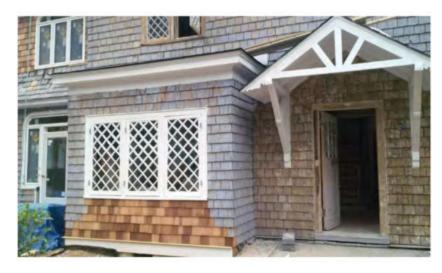
[5] Rotted wood shingles have been replaced in kind with matching wood shingles.

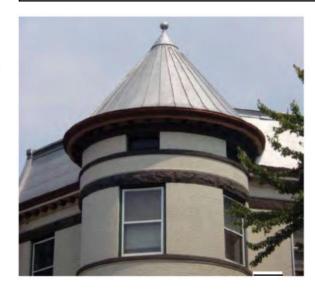
METALS: WROUGHT AND CAST IRON, STEEL, PRESSED METAL, TERNEPLATE, COPPER, ALUMINUM, AND ZINC

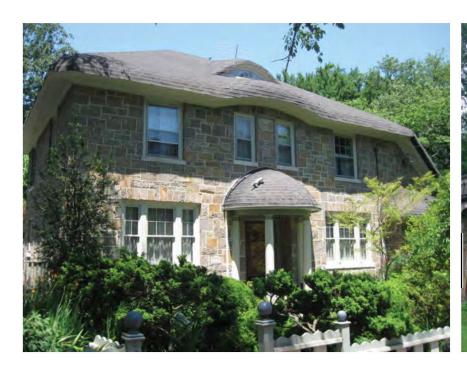
[9] Distinctively-shaped roofs are important in defining the historic character of these early 20lh-century structures: (a) an asphalt shingle roof on a house; (b) and a concrete roof on Fonthill, Doylestown, PA (1908-1912), designed and built by Henry Chapman Mercer.

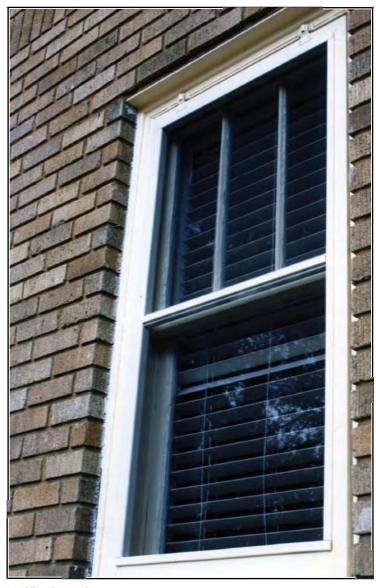
[10] Historic exterior storm windows preserve and help to insulate wood windows.

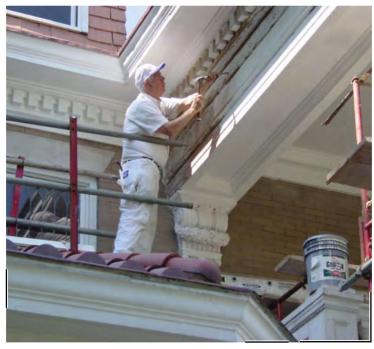
[12] Repair and limited replacement in kind to match deteriorated wood porch features is always a recommended preservation treatment.

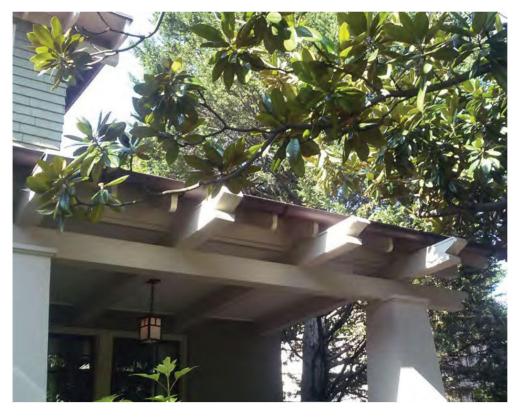
ENTRANCES AND PORCHES

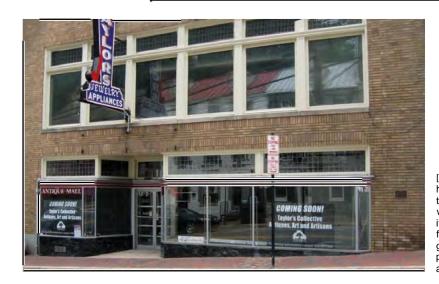
[15] Regular maintenance has helped to preserve this historic storefront, which retains all of its character-defining features, including the granite bulkhead, multipaned transom glazing, and recessed entrance.

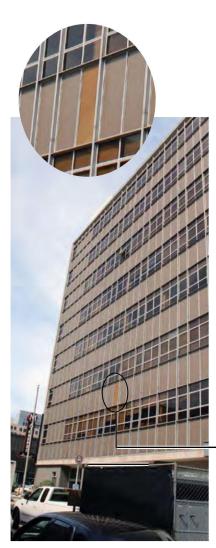
[16] Plywood provides temporary protection for an opening where a damaged spandrel panel was removed until a matching replacement panel can be installed.

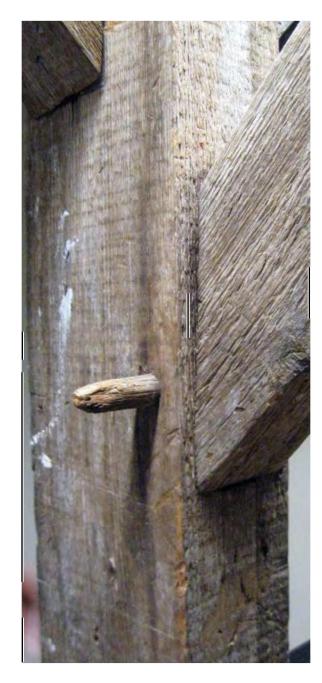
Stabilizing deteriorated or damaged structural systems as a preliminary measure, when necessary, prior to undertaking preservation work.	Failing to stabilize a deteriorated or damaged structural system until additional work is undertaken, thereby allowing further damage to occur to the historic building.
	Failing to protect and maintain the structural system on a cyclical basis so that deterioration of the structural system results.
Protecting and maintaining the structural system by keeping gutters and downspouts clear and roofing in good repair; and by ensuring that wood structural members are free from insect infestation.	Using treatments or products that may retain moisture, which accelerates deterioration of structural members.

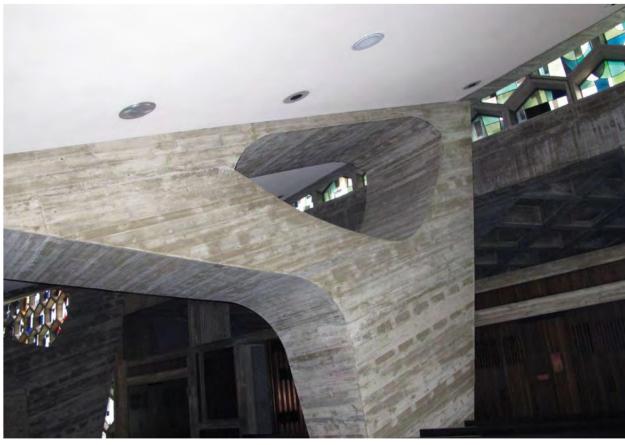
[17] Distinctive examples of traditional construction techniques should be preserved, such as this wooden peg, which is part of the structural system of this late-19th-century warehouse.

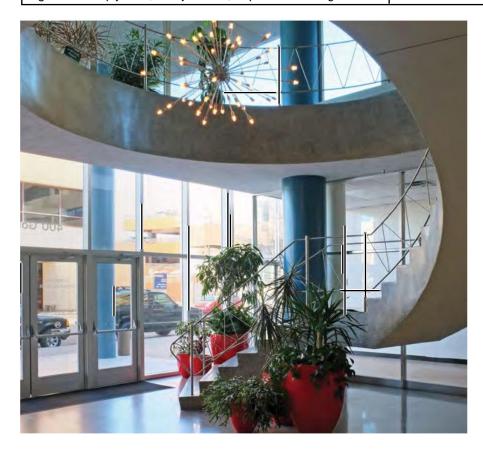
Failing to protect interior features and finishes when working on the interior.

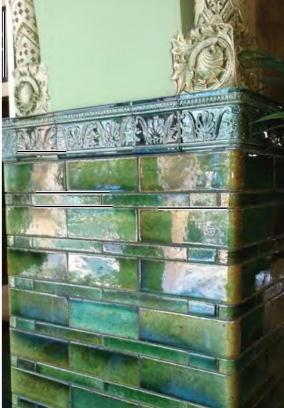
[19] The sweeping staircase with its metal railing, chandelier, and terrazzo floor in the lobby of the 1954 Simms Building, Albuquergue, NM, are character—defining features. Photo: Harvey M. Kaplan.

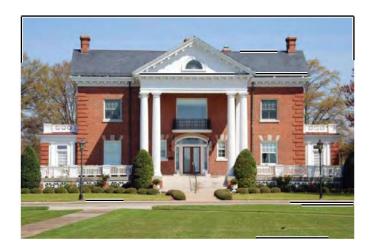
[22 a-b] The 1907 Commander General's Quarters facing Continental Park is one of many important structures that contribute to the historic significance and character of Fort Monroe, a National Monument, in Hampton, VA.

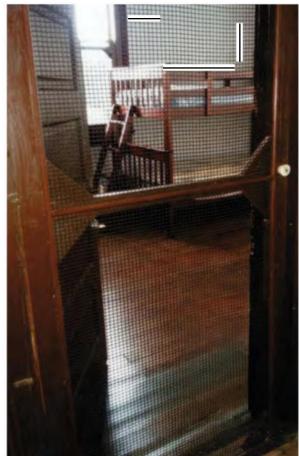
[31] An interior screen door at the entrance to individual apartments is a historic feature traditionally used to help circulate air throughout the building.

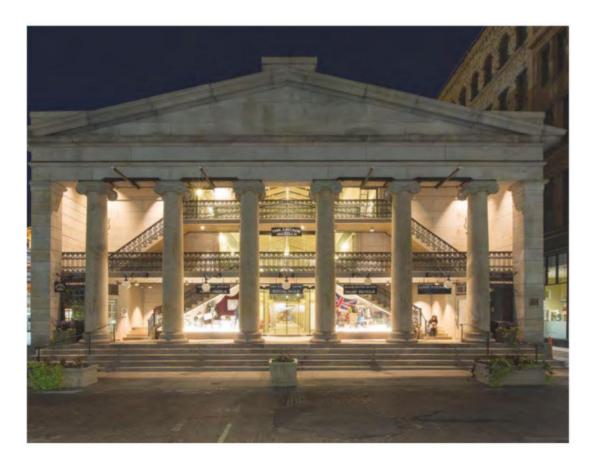
Standards for Rehabilitation

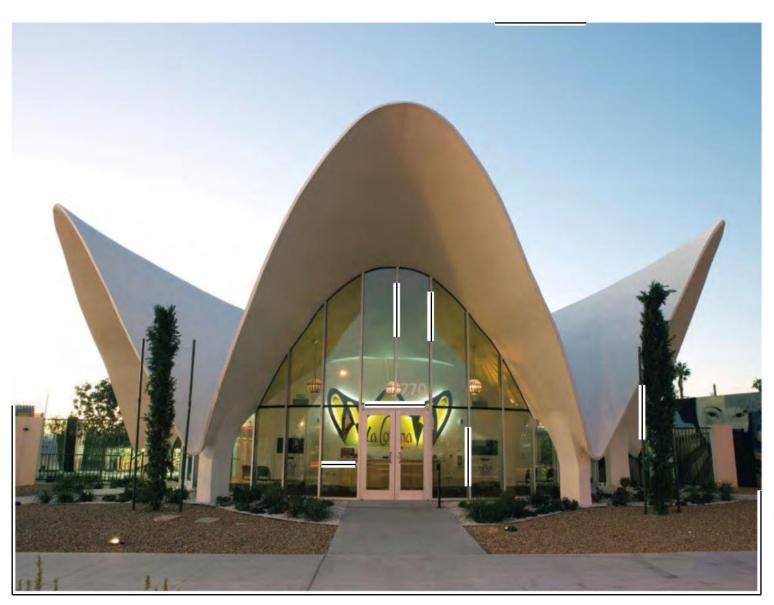
[2] Mid-century modern building technology made possible the form of this parabolanshaped structure and its thin concrete shell construction. Built in 1961 as the lobby of the La Concha Motel in Las Vegas, it was designed by Paul Revere Williams, one of the first prominent African-American architects. It was moved to a new location and rehabilitated to serve as the Neon Museum, and is often cited as an example of Googie architecture. Credit: Photographed with permission at The Neon Museum, Las Vegas, Nevada.

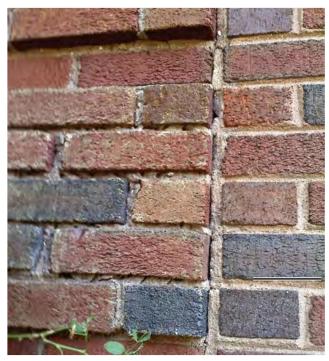
RECOMMENDED NOT RECOMMENDED

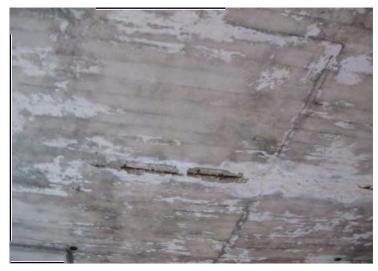
[5] Rebars in the reinforced concrete ceiling have rusted, causing the concrete to spall. The rebars must be cleaned of rust before the concrete can be patched.

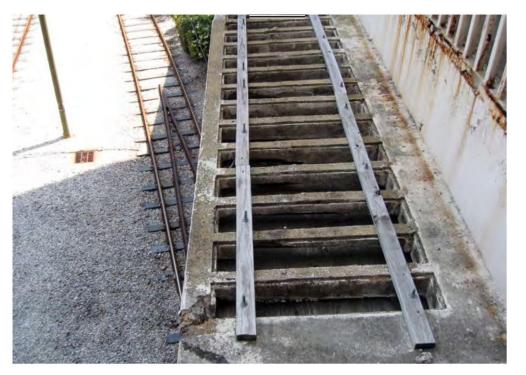
[6] Some areas of the concrete brise soleil screen on this building constructed in 1967 are badly deteriorated. If the screen cannot be repaired, it may be replaced in kind or with a composite substitute material with the same appearance as the concrete.

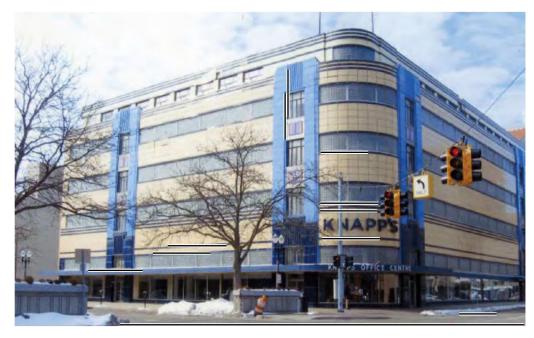
[7] (a) J.W. Knapp's Department Store, built 1937-38, in Lansing, MI, was constructed with a proprietary material named "Maul Macotta" made of enameled steel and cast-in-place concrete panels. Prior to its rehabilitation, a building inspection revealed that, due to a flaw in the original design and construction, the material was deteriorated beyond repair. The architects for the rehabilitation project devised a replacement system (b) consisting of enameled aluminum panels that matched the original colors (c). Photos and drawing (a-b): Quinn Evans Architects; *Photo (c): James Haefner Photography*.

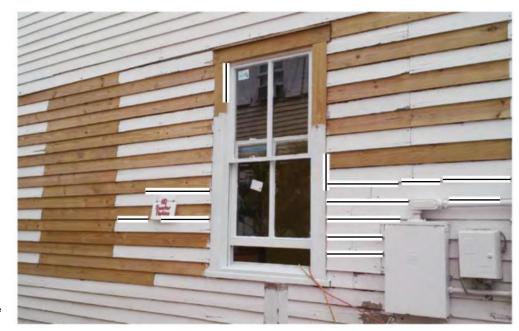
[8] Rotted clapboards have been replaced selectively with new wood siding to match the originals.

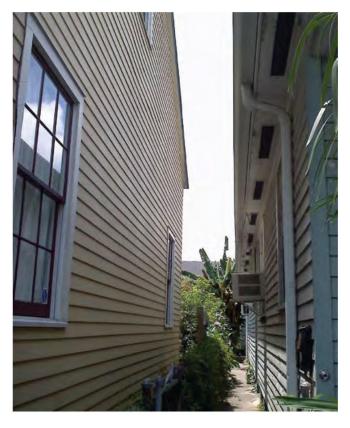
[9] Smooth-surfaced cementitious siding (left) may be used to replace deteriorated wood siding only on secondary elevations that have minimal visibility.

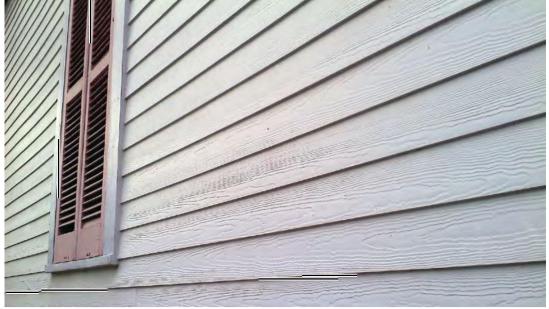
[10] Not Recommended: Cementitious siding with a raised wood-grain texture is not an appropriate material to replace historic wood siding, which has a smooth surface when painted.

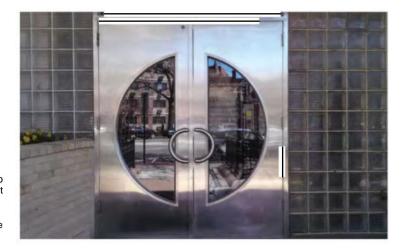
[11] The stainless steel doors at the entrance to this Art Deco apartment building are important in defining its historic character and should be retained in place.

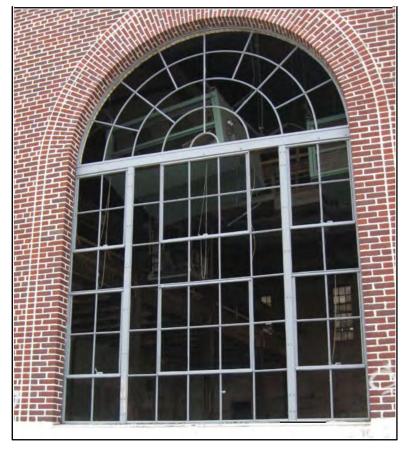
[12] This historic steel window has been cleaned, repaired, and primed in preparation for painting and reglazing.

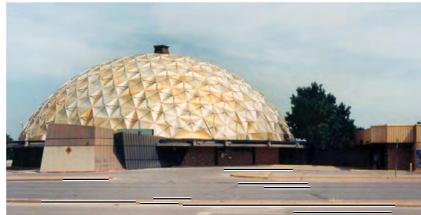
[13] The gold-colored, anodized aluminum geodesic dome of the former Citizen's State Bank in Oklahoma City, OK, built in 1958 and designed by Robert Roloff, makes this a distinctive mid-20th century building.

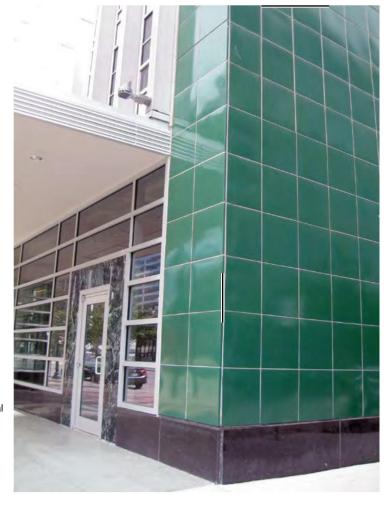
[15] New enameled-metal panels were replicated to replace the original panels, which were too deteriorated to repair, when the storefront of this early 1950s building was recreated.

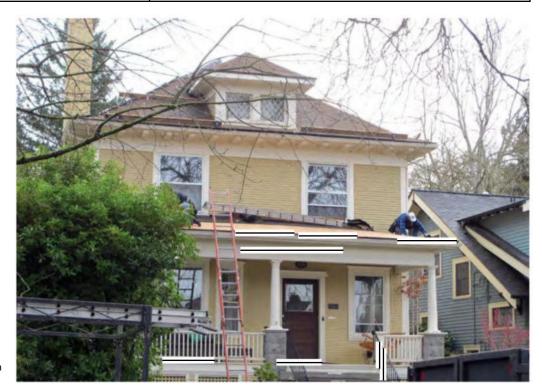
[16] The deteriorated asphalt shingles of this porch roof are being replaced in kind with matching shingles.

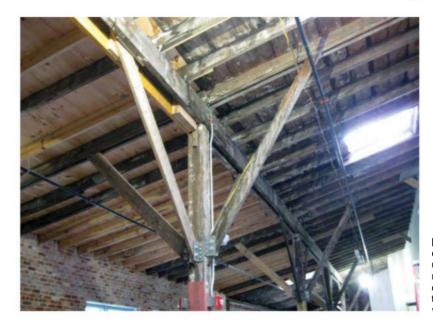
[17] New wood elements have been used selectively to replace rotted wood on the underside of the roof in this historic warehouse.

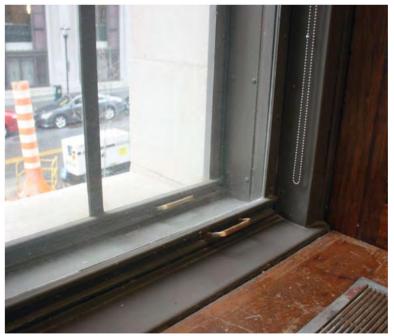
[18] The historic metal storm windows in this 1920s office building were retained and repaired during the rehabilitation project.

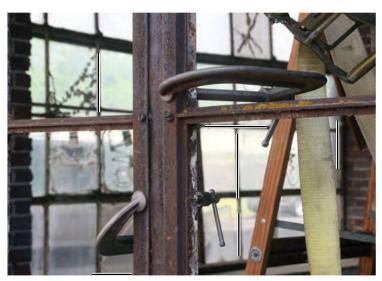
[20 a-d] The original steel windows in this industrial building were successfully repaired as part of the rehabilitation project (left).

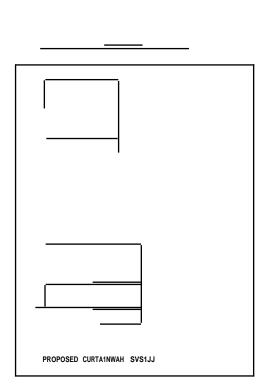
[31 a-c:] (a) The rehabilitation of the First Federal Savings and Loan Association building in Birmingham, AL, constructed in 1961, required replacing the deteriorated historic curtain wall system because the framing and the fasteners holding the spandrel glass and the windows had failed, (b) Comparative drawings show that the differences between the replacement system, which incorporated new insulated glass to meet wind-load requirements, and the original system are minimal, (c) The replacement system, shown after completion of the project, has not altered the historic character of the building.

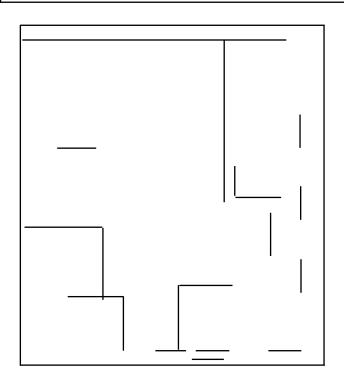
Adding conjectural landscape features to the site (such as period reproduction light fixtures, fences, fountains, or vegetation) that are historically inappropriate, thereby creating an inaccurate appearance of the site.

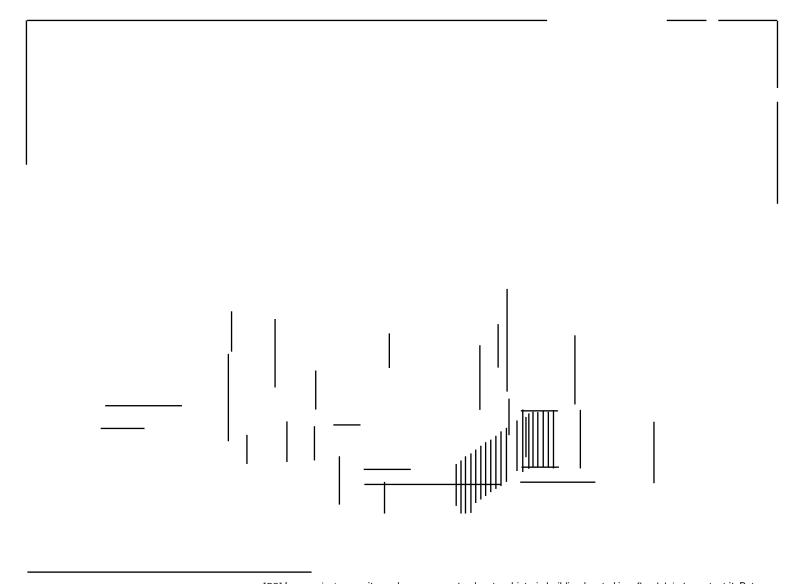
[60] In some instances, it may be necessary to elevate a historic building located in a floodplain to protect it. But this treatment is appropriate only if elevating the building will retain its historic character, including its relationship to the site, and its new height will be compatible with surrounding buildings if in a historic district. The house on the right, which has been raised only slightly, has retained its historic character. The house on the left has been raised several feet higher, resulting in a greater impact on the historic character of the house and the district.

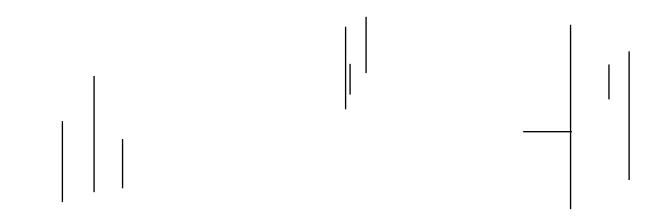
[61 a-b] The materials, design, and location at the back of the historic house are important factors in making this a compatible new addition. Photos: © Maxwell MacKenzie.
